AIRCRAFT ACCIDENT INVESTIGATION REPORT

Japan Air Lines Co., Ltd.
Boeing 747 SR-100, JA8119
Gunma Prefecture, Japan
August 12, 1985

Aircraft Accident Investigation Commission
Ministry of Transport

June 19, 1987

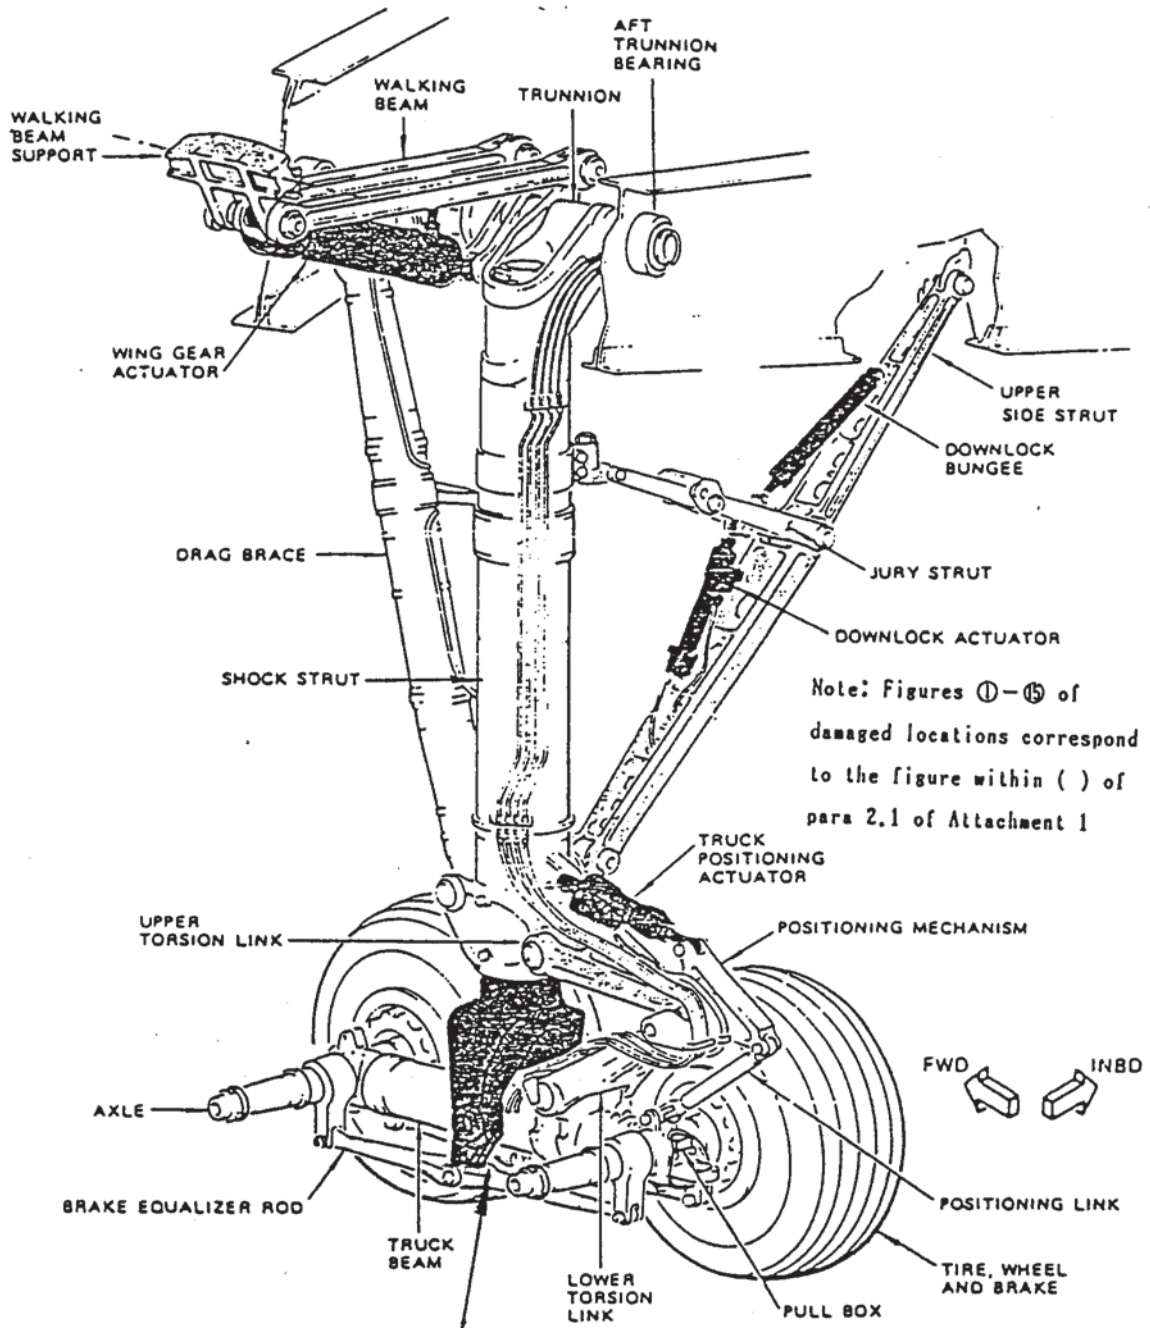
Attachment 1 Attached Figure-2
 Damaged Portions by Accident (2)

dents (8 in total for the right and left)
